# COMFORT CONDITIONS IN A HABITAT FOR HUMANITY HOUSE IN CENTRAL TEXAS

## ABSTRACT

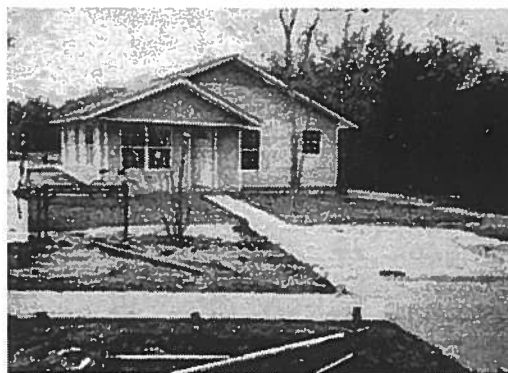
**Figure 1:** Case Study Habitat House. This photo shows the front (north side) of the case study house shortly after construction was completed.

The Habitat for Humanity house used in this study is a single-story 1048 ft<sup>2</sup>, three-bedroom house with an attic space (Figure 1) and is located in Bryan, Texas. The measured data are recorded with an on-site data logger that was installed during the 1997 construction period. The house consists of a kitchen/dining area, utility room and two bathrooms. The house has a 64ft<sup>2</sup> front porch and a 42ft<sup>2</sup> patio at the rear of the house.

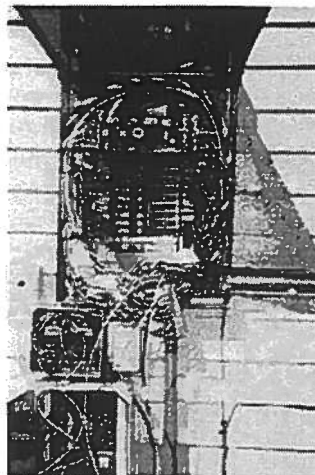
**Figure 2:** Electrical and Thermal sensors for the Case Study House. This photo shows the electrical panel for the case study house where the current transformers and voltage reference were installed. Directly below the distribution panel is the power supply for the logger and the Btu meter for the domestic water heater.

Photos of the monitoring equipment are included in Figures 2-5. Figure 2 is a photo of the electrical panel for the case study house where the current transformers and voltage reference were installed.

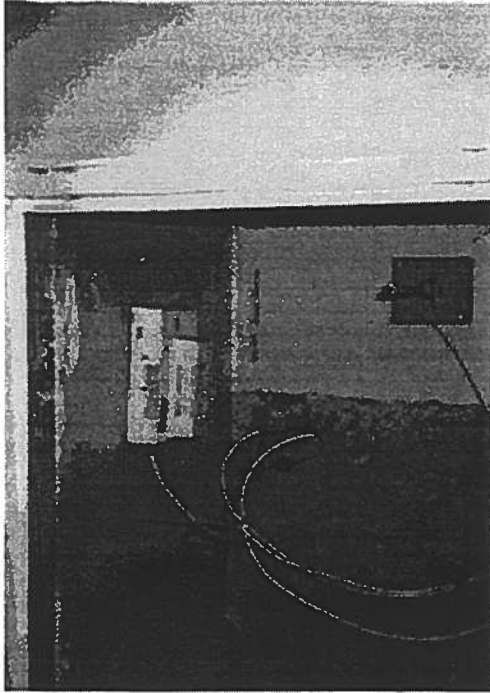
**Figure 4: Indoor Environmental Sensors.** This photo shows the indoor monitoring station for temperature, humidity and CO<sub>2</sub> located in the hallway return air plenum.

Data, telephone and 24 VAC power are provided in buried conduit that runs between the house and the support pole. Figure 4 is a photo of the indoor monitoring station for temperature, humidity and CO<sub>2</sub> located in the hallway return air plenum. Figure 5 is a photo of the combined temperature-humidity sensor and PVC radiation shield located in the attic of the case study house.

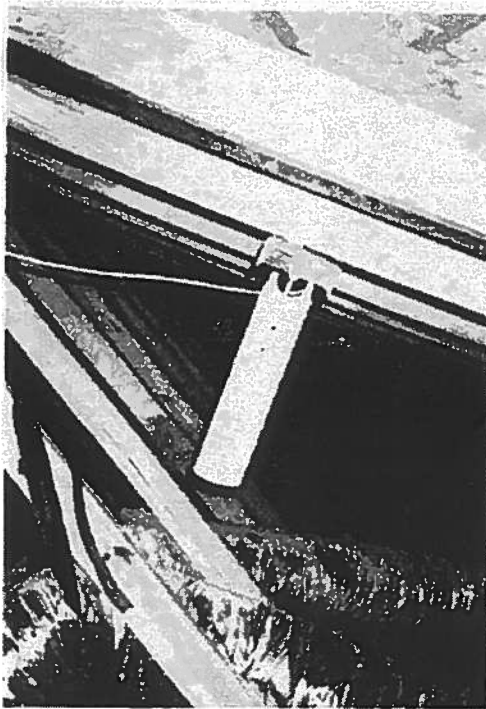
**Figure 5. Attic Temperature and Humidity Sensor.** This figure shows the combined temperature-humidity sensor and PVC radiation shield located in the attic of the case study house

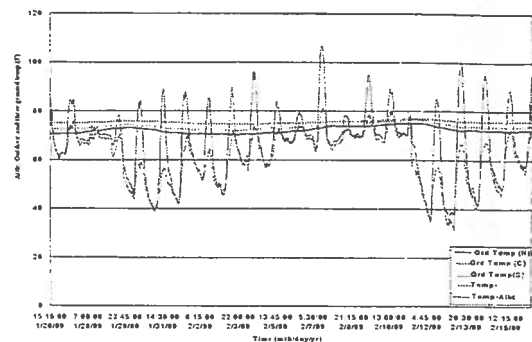
**Figure 6: 15-minute Environmental Temperatures Measured at the Case Study House.** This figure shows measured 15-minute temperatures from the attic, ambient, and indoor air sensors, along with ground temperatures located below the slab in the center of the house [C], and 3 feet from the edge of the slab on the [N] and south [S] sides.

Preliminary results of the monitoring efforts are included in Figures 6 to 13. Figure 6 shows measured 15-minute temperatures from the attic,

ambient, and indoor air sensors, along with ground temperatures located below the slab in the center of the house [C], and 3 feet from the edge of the slab on the [N] and south [S] sides for a three week period in January-February 1999. It is clear from figure 6 that the ceiling and walls of the house are exposed to significant variations in diurnal exterior temperatures with ambient wall temperatures varying from 30 F to 80 F and attic temperatures varying from 30 F to over 100 F. The attic temperatures rise significantly above the ambient temperatures during the daytime, as the solar heat gain penetrates the surface of the roof. However, the attic temperatures almost always drop to the same temperature as the ambient temperatures each evening – an effect of night sky radiation and the vented attic. The elevated attic temperatures contribute to the duct heat gain during the cooling season, and to a lesser extent, contribute to the space heat gain because of the R-19 insulation.

During this same period the measured ground temperatures directly below the concrete slab varied little with the center of the slab remaining the closest to the indoor air temperature. The temperatures near the edges of the slab are slightly lower than the central slab temperature indicating the uninsulated edges of the concrete slab are allowing the exterior cold temperatures to penetrate into the interior of the house. Figure 7 shows measured ground temperatures located below the slab in the center of the house [C], and 3 feet from the edge of the slab on the [N] and south [S] sides for a 6-month period from December 1998 to June 1999. These measured temperatures clearly show that there are significant periods in the winter when the edges of the concrete slab are well

Several other features are evident as well from Figures 6 and 7. First, in Figure 6 during the three-week period that is shown there was a warming period in the middle of February followed by 40+ F

drop in temperature on February 11<sup>th</sup>. During the warming period the slab temperatures converged towards the room temperature. Whereas, one day following the outdoor temperature drop the temperatures at the edges of the slab started to drop away from the center slab temperature. Second, in Figure 7 the temperature of the center of the slab remains relatively constant throughout the 6-month period due to the direct contact with the conditioned air in the building. Finally, the edges of the slab vary from about 60°F in the middle of the winter to almost 80°F by the summer, indicating a significant influence from the outdoor temperature.

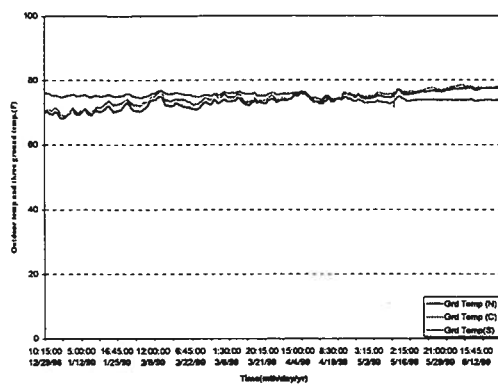
**Figure 7:** Daily Ground Temperatures Measured at the Case Study House. This figure shows measured ground temperatures located below the slab in the center of the house [C], and 3 feet from the edge of the slab on the [N] and south [S] sides for a 6 month period from December 1998 to June 1999.

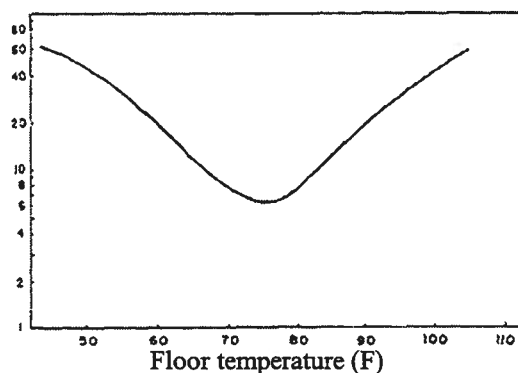
**Figure 8:** Percentage of people dissatisfied as a function of floor temperature.

below the 77°F recommended by ASHRAE for bare feet in contact with an uncarpeted floor (Figure 8).

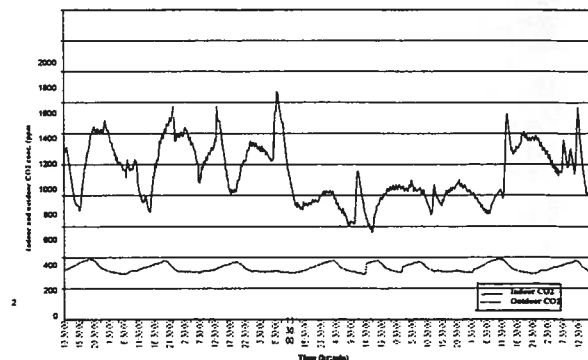
**Figure 9:** 15-minute Measured Indoor and Outdoor CO<sub>2</sub> Concentrations. This figure shows measured 15-minute indoor-outdoor CO<sub>2</sub> concentrations from the case study house for the period 12/28/98 to 1/5/99.

Figures 9 and 10 show measured indoor-outdoor CO<sub>2</sub> concentrations. Figure 9 shows 15-minute measured indoor and outdoor CO<sub>2</sub> concentrations for one week for the period 12/28/98 to 1/5/99. Clearly, there are significant periods when the house is well above the 1,000 ppm recommended by ASHRAE. Figure 10 shows 15-minute measured indoor and outdoor CO<sub>2</sub> concentrations for the 2-1/2 month period from 5/13/98 to 7/31/98. During this period, there is a period of 10 days when the indoor CO<sub>2</sub> concentration never falls below 1,000 ppm and isolated spikes when the CO<sub>2</sub> concentrations topped 2,500 ppm. However, there are also periods when the CO<sub>2</sub> concentrations did not rise above 1,000 and a few days when the indoor CO<sub>2</sub> concentrations matched the outdoor concentrations. Clearly, one can conclude from these data that the CO<sub>2</sub> concentrations are very dependent upon how many people are in the house and whether or not the house has any windows open.

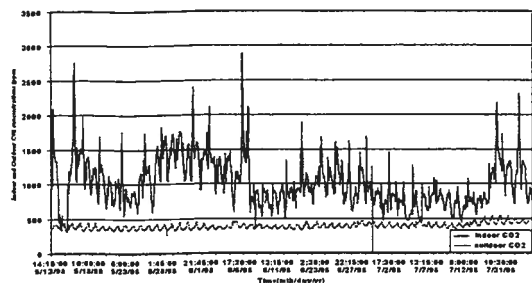
**Figure 10:** 15-minute Measured Indoor and Outdoor CO<sub>2</sub> Concentrations. This figure shows one week of measured 15-minute indoor-outdoor CO<sub>2</sub> concentrations from the case study house for the period 5/13/98 to 7/31/98.

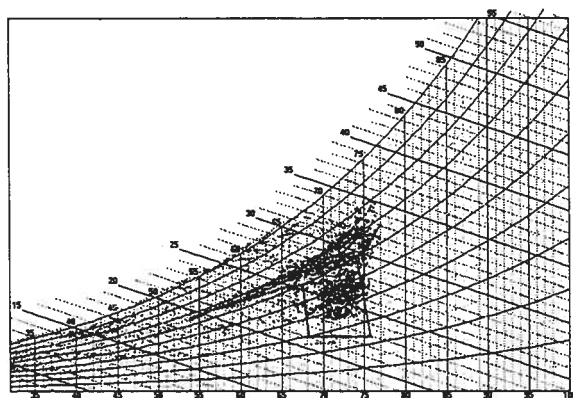
**Figure 11:** Indoor/outdoor temperature and humidity displayed on the psychrometric chart (heating mode). This figure shows the measured indoor temperature-humidity displayed on the psychrometric chart during the heating season for the period January to March 1999.

Indoor temperature-humidity measurements were also recorded to help analyze the thermal comfort of the house as shown in Figures 11 and 12. In Figure 11 the indoor-outdoor temperature and humidity are displayed on the psychrometric chart for the 3-month period from January 1999 to March 1999. Figure 12 shows the indoor-outdoor temperature and humidity for the Month of August 1999.

During the heating mode (Figure 11) several features can be seen in the data. First, there are two distinct indoor temperature-humidity groups: one group where the heating system was clearly operating and the resultant temperature-humidity condition stayed within the confines of the ASHRAE comfort chart for heating (i.e., 60% RH, 68 – 75°F and 36 Twb).

The second mode is a group of indoor temperature-humidity data that fall outside the comfort zone and represent either a) periods when ambient temperatures were cold but the heating system was not active (i.e., temperatures colder than the comfort zone), or b) periods when the humidity levels are above the 60% RH recommended by ASHRAE for mold and mildew control.

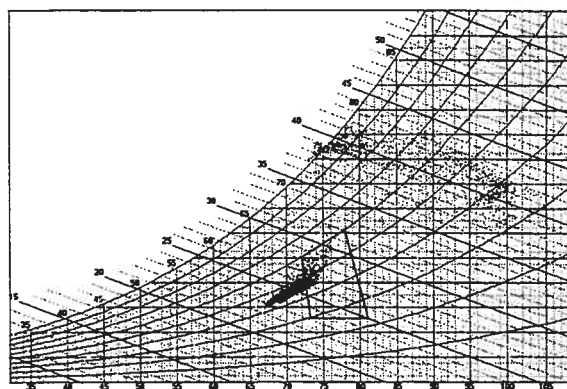
**Figure 12:** Indoor/outdoor temperature and humidity displayed on the psychrometric chart (cooling mode). This figure shows the measured indoor temperature-humidity displayed on the psychrometric chart during the cooling season for the month of August 1999.

During the cooling season (Figure 12), a dramatically different picture emerges about the indoor comfort conditions. In this period, which represents the month of August 1999, ambient conditions varied from 75°F to 100°F and were always more humid than the ASHRAE comfort zone, forcing the Habitat homeowner to continuously run her air conditioner. This continuous air-conditioning produced a very tight grouping of the indoor temperature-humidity measurements that range from 65 to 75°F and remained almost entirely within a 40 to 50% RH band.
